ATTACHMENT TO L-1377  
01 AUGUST 1966  
PAGE 1

PETROLEUM PRODUCTS STORAGE  
VIET TRI, NORTH VIETNAM  
2117N 10526E

PETROLEUM PRODUCTS STORAGE  
VIET TRI, NORTH VIETNAM  
21-17N 105-26E

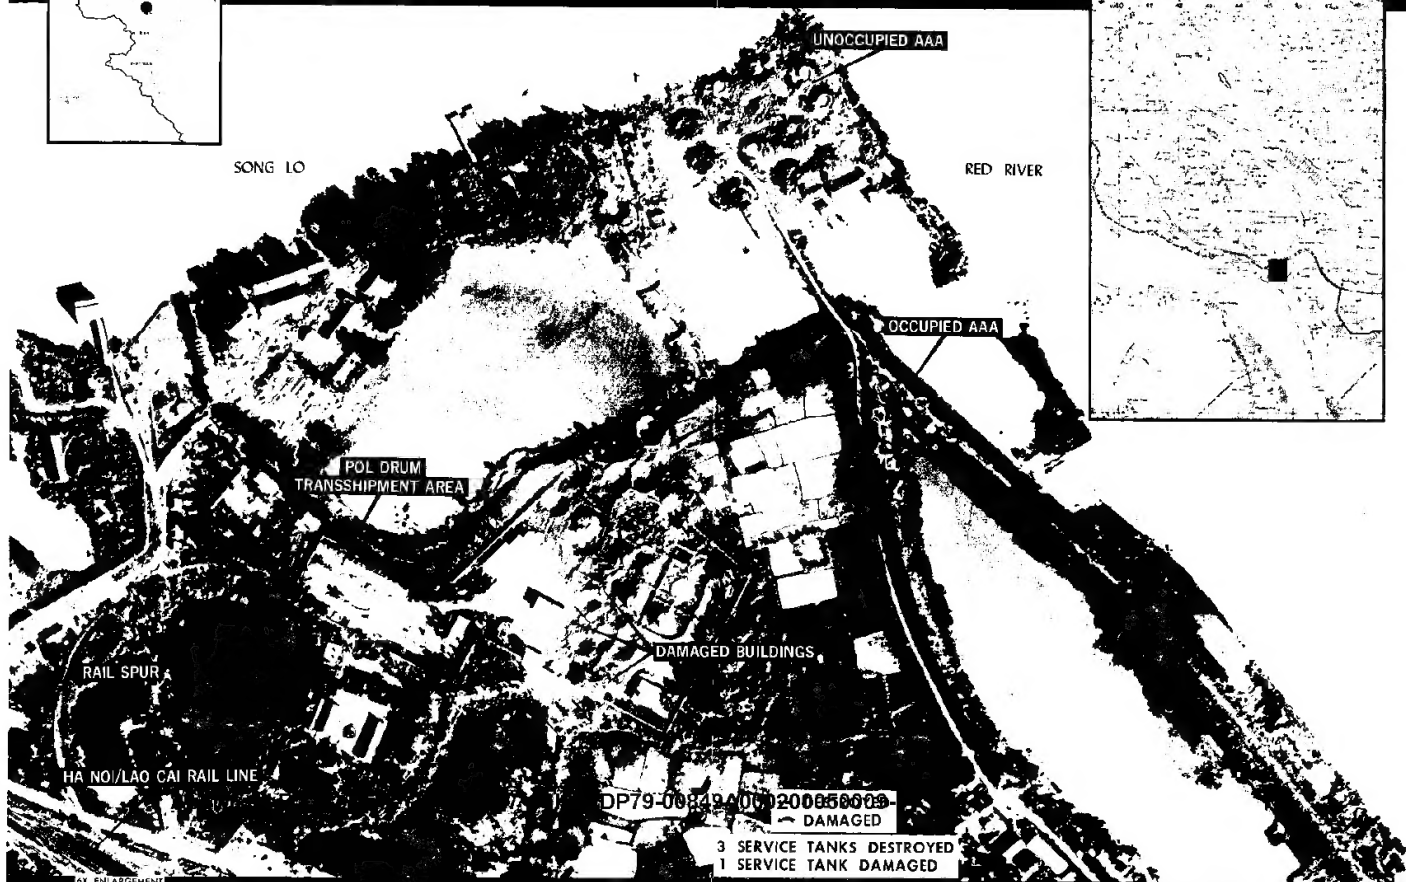
6X ENLARGEMENT  
NPIC L-4377 (7/86)

POST-STRIKE PHOTOGRAPHY OF [REDACTED] REVEALS THREE  
DESTROYED SERVICE TANKS, ONE DAMAGED TANK, AND THREE DAMAGED BUILDINGS.  
NO DAMAGE IS OBSERVED TO THE POL DRUM TRANSSHIPMENT AREA SERVED BY A  
RAIL SPUR WHICH CONNECTS TO THE HA NOI/LAO CAI RAIL LINE.

DAMAGED

3 SERVICE TANKS DESTROYED  
1 SERVICE TANK DAMAGED
